Heritage Conservation Plan

June 2018

Holy Family Parish Church - 521 4 Avenue - Fernie, BC

Elana Zysblat, CAHP + John Atkin - heritage consultants

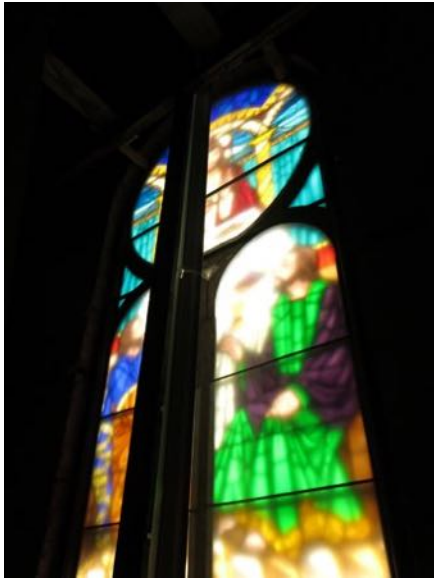
Left: The current bell-tower window as seen from inside the bell tower. The vertical form in the centre is a florescent light that gets turned-on at night to illuminate the window. Sheets of white poly carbonate have been installed on the inside of the window and may be the cause of the blurred image seen at night from the exterior.

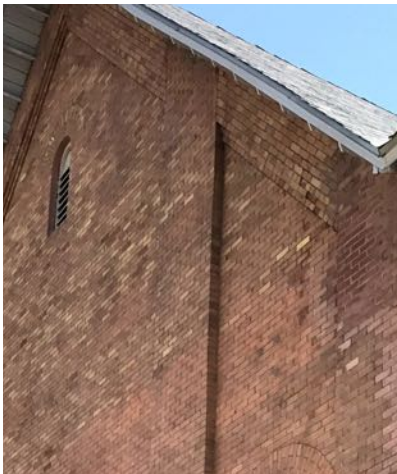
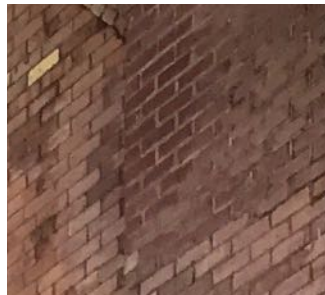
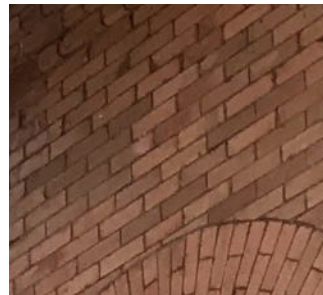
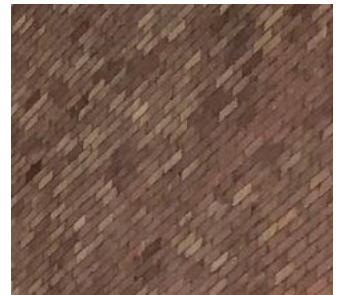
The brick work is in good condition overall. The original brick from Sandpoint, Idaho was set with a narrow joint of scored red mortar. There are number of visible repairs and unfortunately, little attention was paid to the type of brick or mortar used in the repair work. The back wall of the church illustrates this clearly.

Brick repair on the back wall showing different types of bricks used, different mortar types and joint width. This needs to be monitored as incompatible materials can cause additional damage

The condition of the brick cladding is good but a variety of recent inconsistent mortar interventions (see condition assessment) suggest that this work may not perform well over time. Monitor mortar performance regularly, especially at the end of each winter.

Look for evidence that the new mortar may be harder than the historic bricks (not good) and thus augmenting moisture ingress to the brick surface around the mortar (the visible edges). If it becomes evident that the bricks around the new mortar repairs have spalled and eroded, leaving the mortar in place - this would be a sign the mortar mix was incorrect and the area will need to be repointed again, using a professional conservation mason and a compatible, historically appropriate mortar.

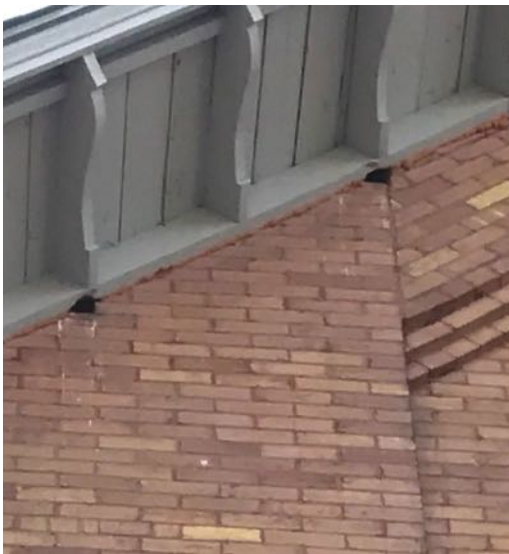
Far left: On the back wall expanding spray foam has been used to unsuccessfully fill gaps between the soffit and brick. Other gaps show activity from birds looking for nesting places in the roof.

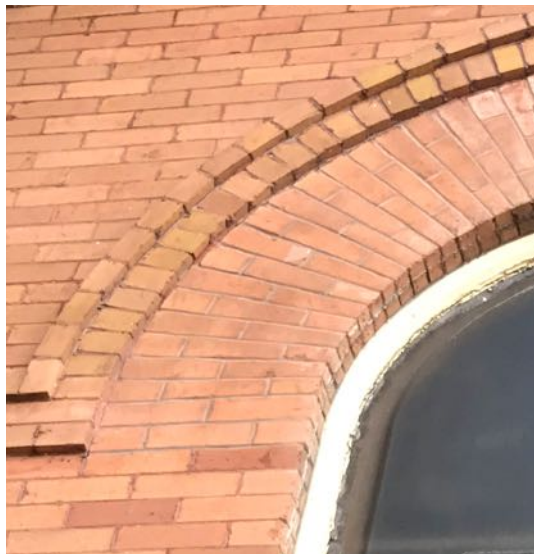
Left: Repair work can be seen in one of the window arches with incorrect mortar colour and joint type.

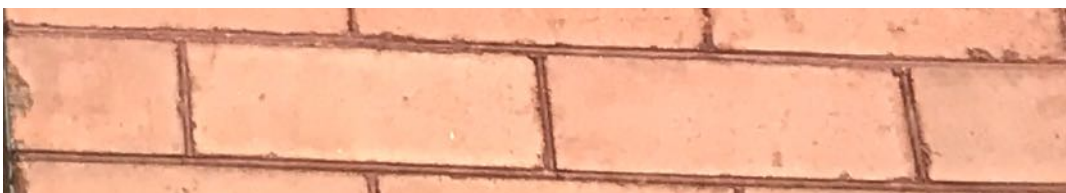
Bottom: original red mortar and the narrow scored joint.

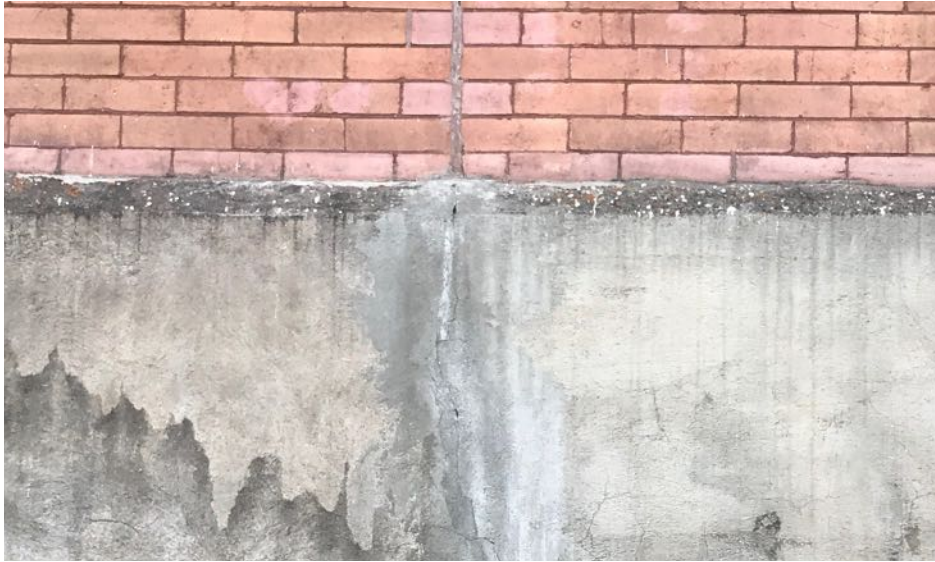
There are some substantial cracks in the concrete foundation, notably at the rear of the church.

Some repair work has been done but it should be assessed periodically by an engineer.

Assess existing foundation cracks using a professional engineer.
If repairs are needed, use professional conservation mason to conduct repairs.

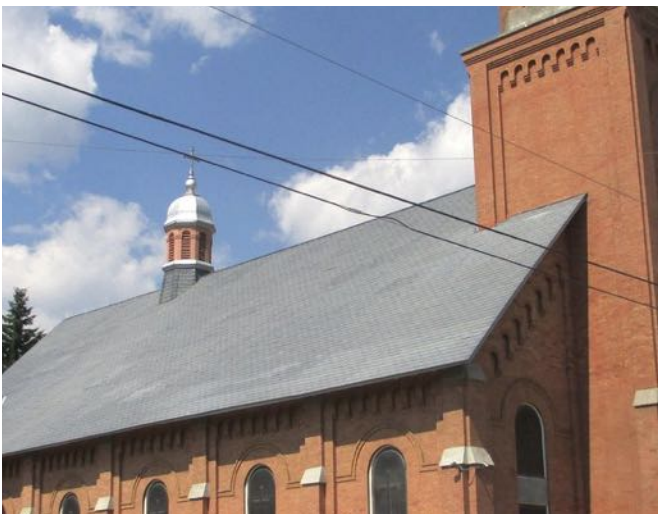
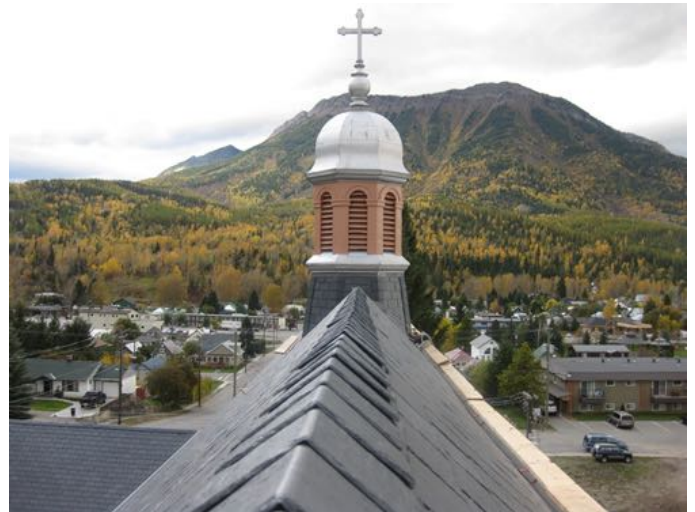
A new synthetic slate roof was installed in 2006, a product that comes with a 50-year warranty. The current condition of the roof, 12 years later, is excellent.

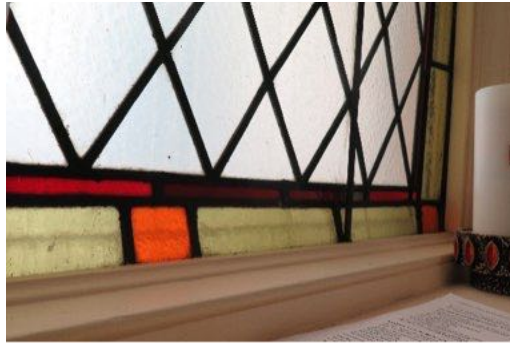
1W Office area - faces west

Three sections - one is opener
Bottom boarder is bowed
Some re-bars are bending

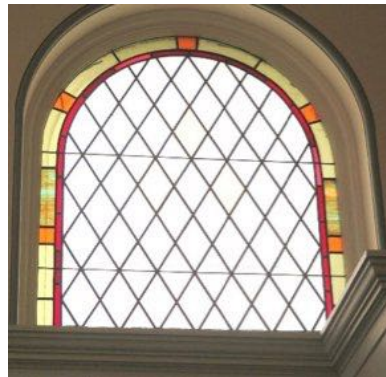
2W Office area above shelving - faces west

Only a few minor cracks

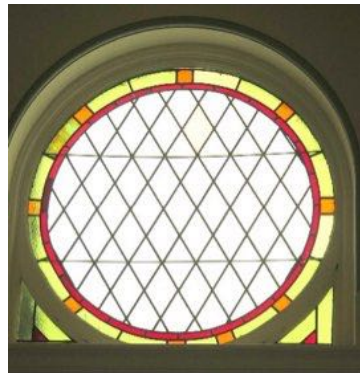
1St Over office door - faces south west

Window in three sections, round part with two corner sections at bottom
Light is visible at top of round portion
A few cracks in all parts of the window

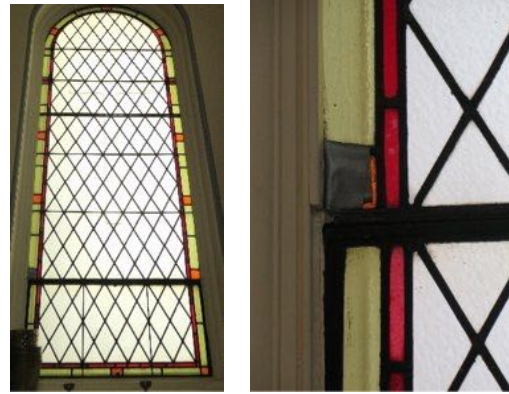
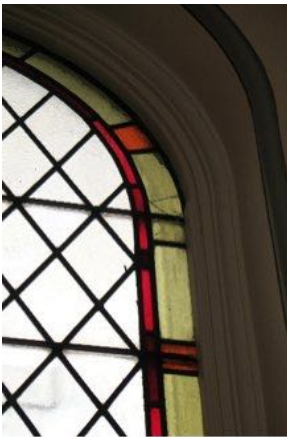
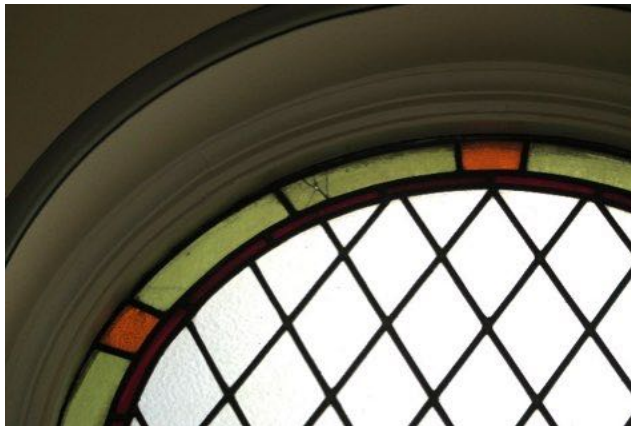
1E Office - facing East

Slightly bowed at bottom boarder
A few cracks, one is covered with tape
Window is opener.
Seems to be in three sections

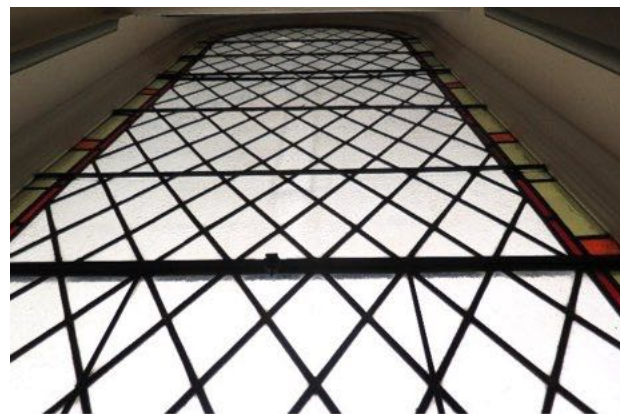
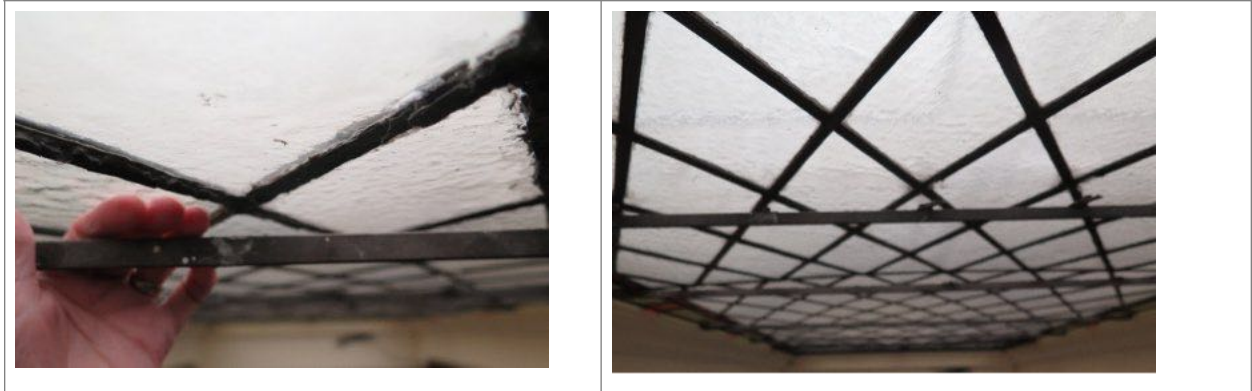
6S Large panel at back of church (crying room) - facing south

This is the worst panel
Is an opener
Non of the re-bars are attached to the window
Some old on-site repairs
Seems to be in three sections.

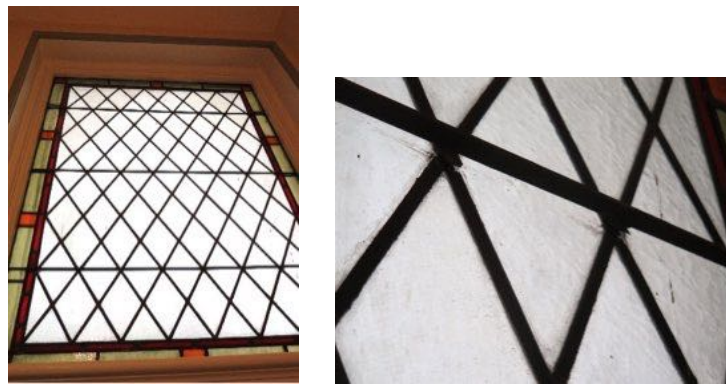
2Eb Bathroom window - faces East

Seems to be in relative good shape
Some of the lead is broken at lower re-bar

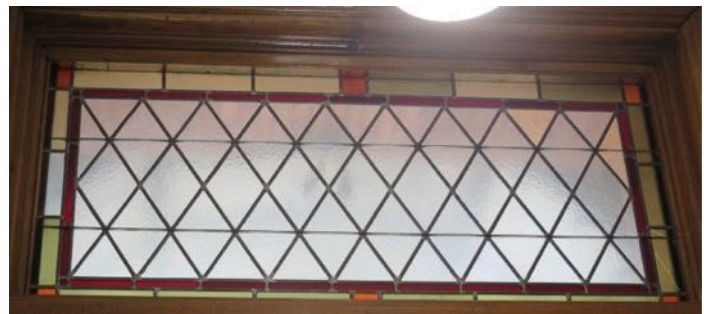
3Eb Transom over entry doors - faces East

A few cracks but otherwise looks in good shape

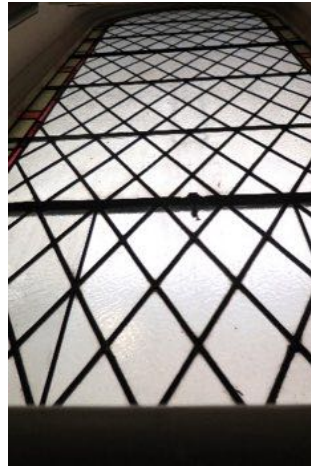
1N Back - Northwest corner of Church

Opener window
Seems in good shape but will probably need to be re-caulked in frame

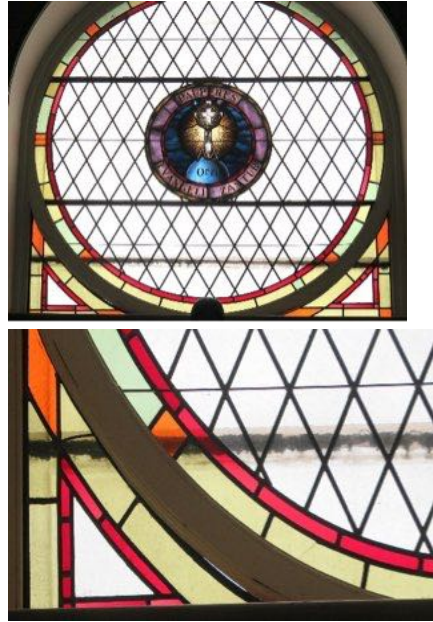
3Em Over entry doors (art-glass centre) second storey window

Three section window, one circular panel and two corner sections at bottom of panel
Left corner piece has daylight showing on curved part
Centre panel is bowed a bit at bottom
Some minor cracks in centre window
Two large re-bars seem to be puttied in and painted
Centre window may be in three sections.

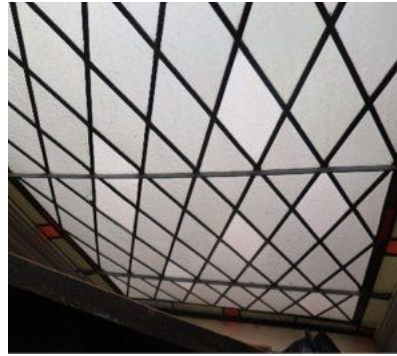
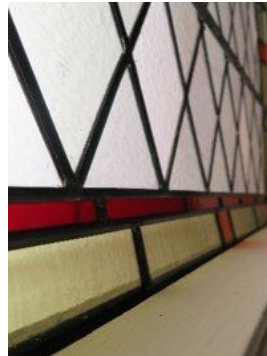
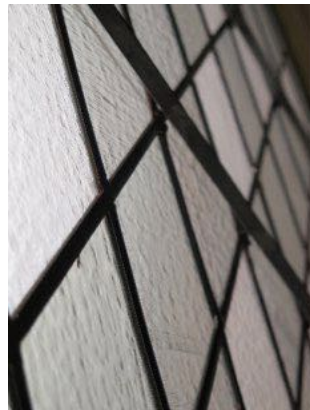
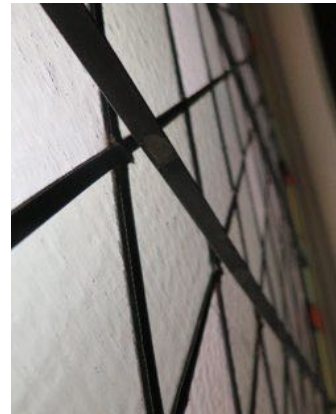
4Eb Back stairwell to upstairs - faces east

Window is actually two separate windows
Bottom panel is bowed at the bottom
Re-bars are not attached
Has a lot of rattle

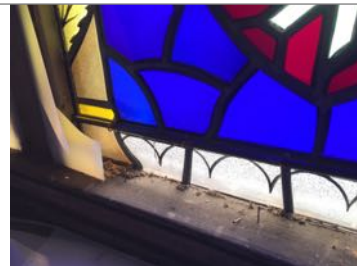
3Et Bell-tower art glass window

the interior white poly carbonate on the bottom corner is missing/broken. An examination of the illumination set-up and the performance of the poly carbonate inside the bell-tower is needed.

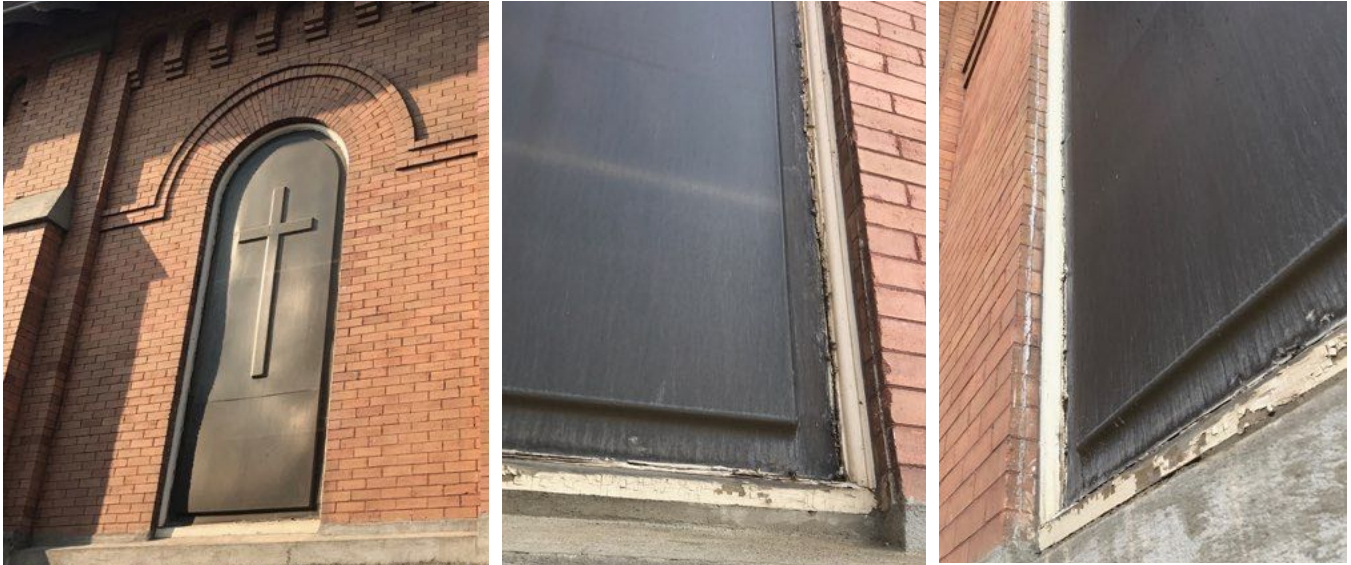
The stained and art glass windows are protected by vacuum-formed panels held in place with a wood moulding. The moulding is in good condition but needs attention to repair some split wood and all trim needs painting. The panels are in very good condition with no obvious signs of damage. The dark colour appears to be intentional/original and not discolouring due to UV rays or dirt.

Left: typical panel showing embossed cross and raised edge that provides rigidity

Middle and right: panels need cleaning to wash away accumulated dirt. Moulding and sills need attention to the paint and caulking

Replacement of the protective panels for aesthetic reasons (the Restoration Committee currently prefers a transparent protective panel) must consider a material and installation model that will perform to the same standard of protection that the current panels have provided for the last 40 years.

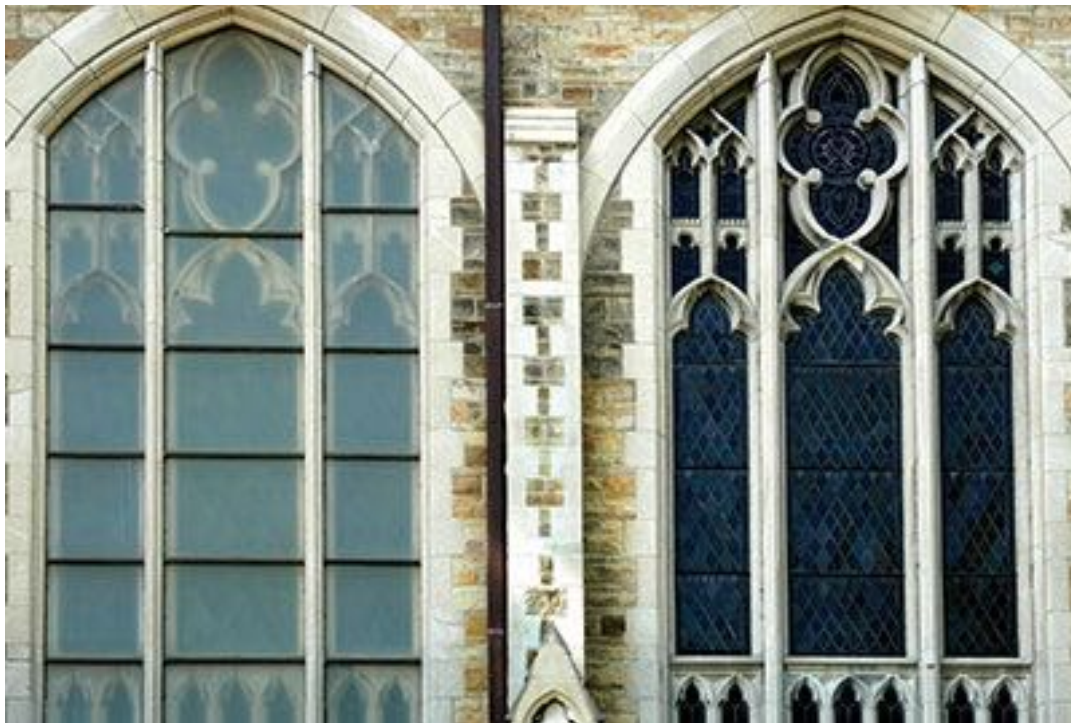
A common error in installing protective glazing is to create a new window configuration (see photo above). Insensitive installations that disregard the original tracery destroy the window's aesthetics—and the building's. On this pair of neo-gothic church windows, the aluminum frame grid used for protective

glazing disregards the original tracery of the window on the left. The grid mars the appearance of the window inside and out. It also impairs the overall historic character of the building. The plastic storm glazing has been removed from the adjacent window to restore the original window appearance.

Protective glazing should be installed in an independent frame between $\frac{5}{8}$ " (16mm) and 1" (25mm) from the historic glass. This allows the protective panel to be removed for periodic maintenance of both the historic window and the new glazing. The conditions of the air space between the two layers should be monitored on a regular basis; condensation should never collect on the window.
