Heritage Conservation Plan

June 2018

Holy Family Parish Church - 521 4 Avenue - Fernie, BC

Elana Zysblat, CAHP + John Atkin - heritage consultants

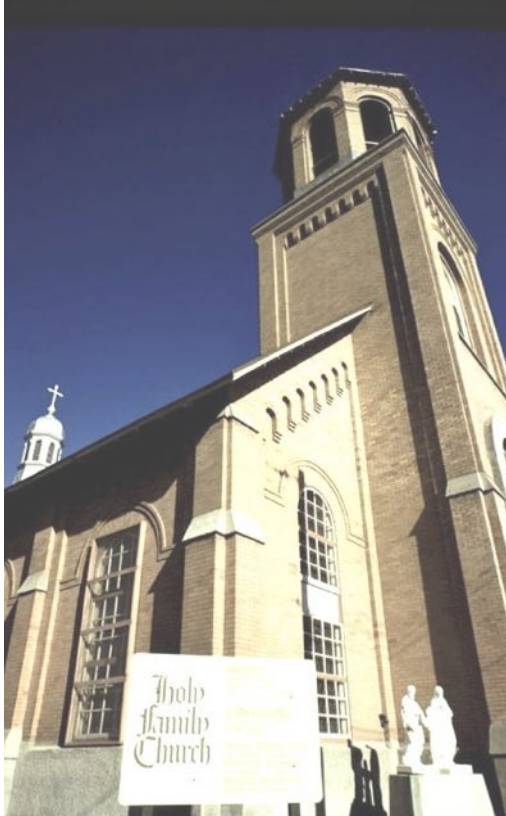
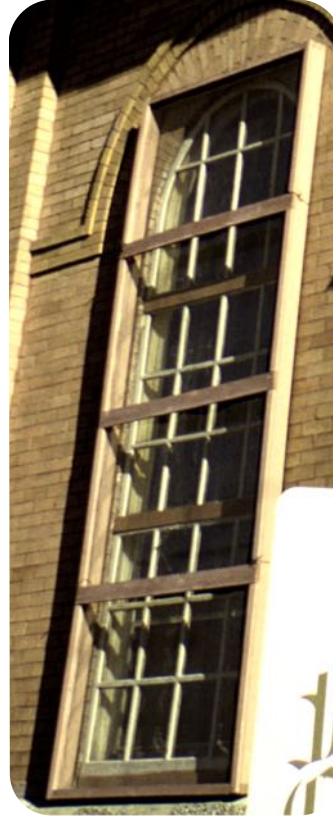
The below photograph of the church taken in 1980 for Beautiful BC magazine, shows temporary wood frames placed on several of the windows, likely to aid the imminent removal of the storm windows in one piece. It appears that the storm windows were removed in 1981 and replaced with the current black covers.

Far left: the Holy Family Church in 1980 photographed by Beautiful BC magazine. source: BC Archives i-08452

Left: crop from the above cited photo, showing the temporary wood frames around one of the windows.

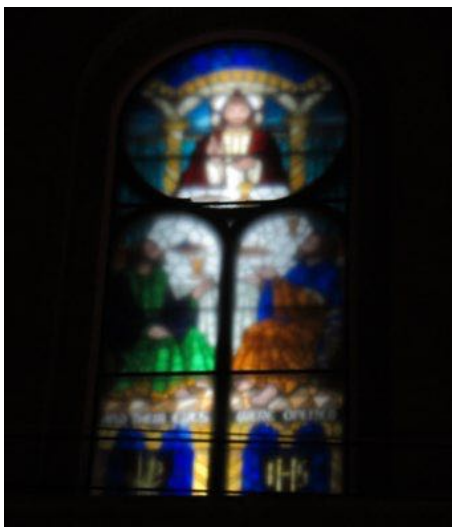
Likely at the time of the protective panel replacement, the surviving 1912 bell-tower windows were removed and replaced with a new art-glass window depicting the institution of the Eucharist. This window is illuminated at night from inside the bell-tower. The original diamond-pattern stained-glass bell tower window assembly leans against a wall inside the bell tower today.

Far left: the illuminated bell-tower window as seen today from the exterior at night source: Stephanie Rogers

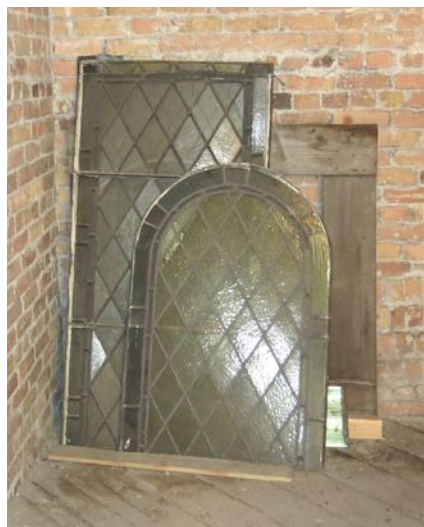
Left: the original 1912 diamond-pattern bell-tower windows leaning against a wall inside the bell tower today.

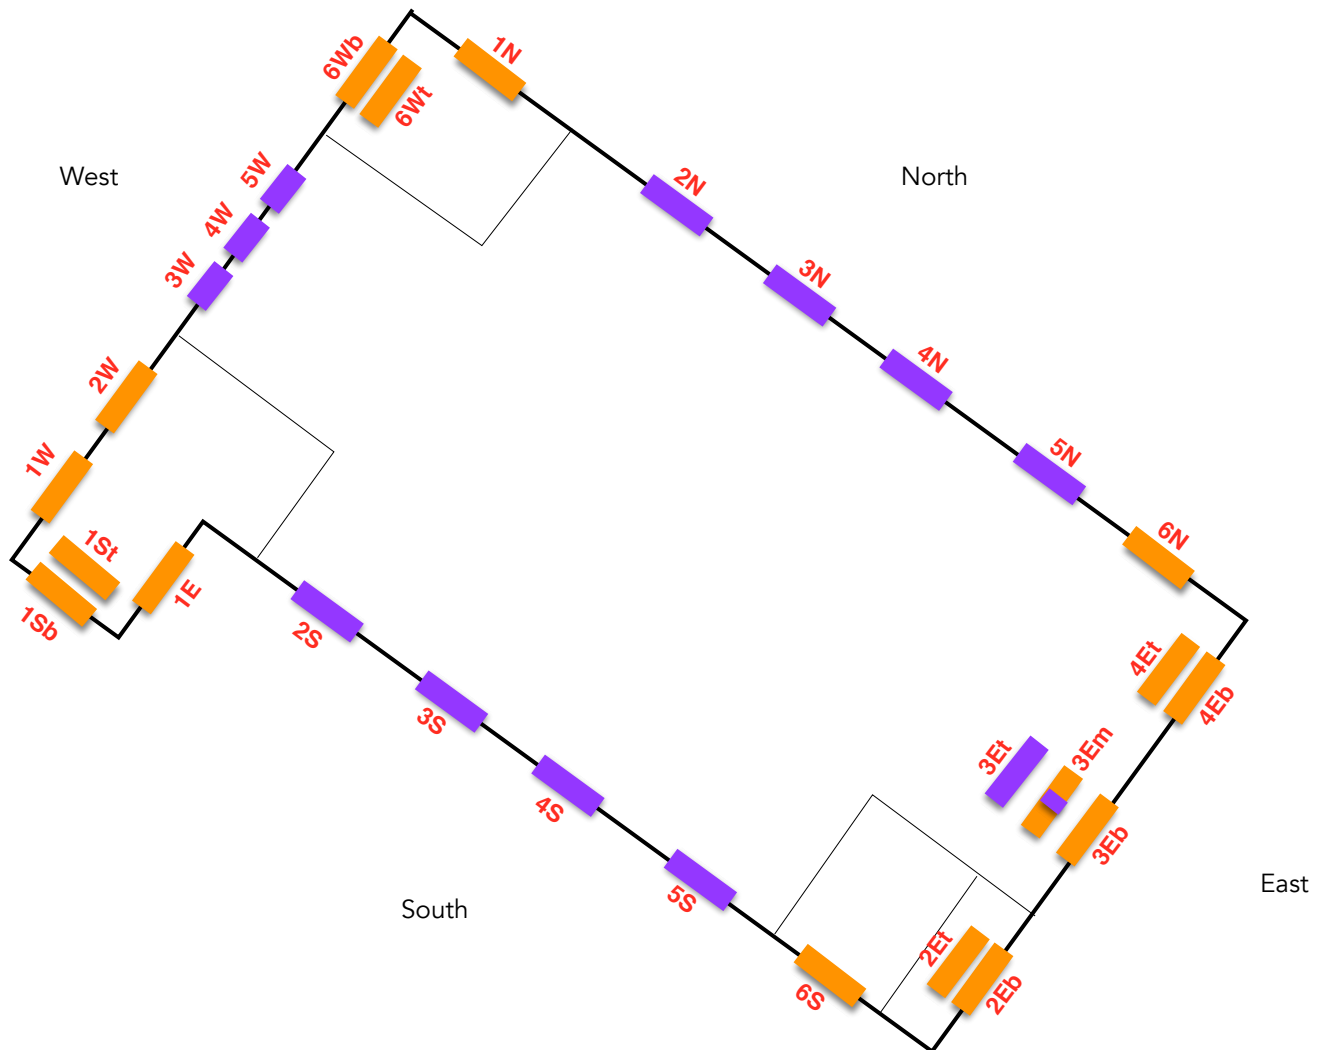
The church features 27 original windows made by the Luxfer Prism Co. (Toronto), for the 1912 building, and one 3-part feature art-glass window in the bell-tower dating from the 1980s which replaced a diamond-pattern 1912 stained-glass window. All the windows except for the bell-tower window, have been covered on the exterior over the decades by protective panels - wood sash storms until 1981, and the current covers since 1981. "...extensive re-leading and reglazing" of the 1912 windows was carried out in 1963³. The map below shows their location in the building and whether they are diamond-pattern stained-glass windows (indicated in orange), or art-glass windows (indicated in purple).

Overall, the art-glass windows (indicated in purple) are in good condition and do not need repairs. Most of the diamond-pattern stained-glass windows however, are damaged in places and are in need of repairs.

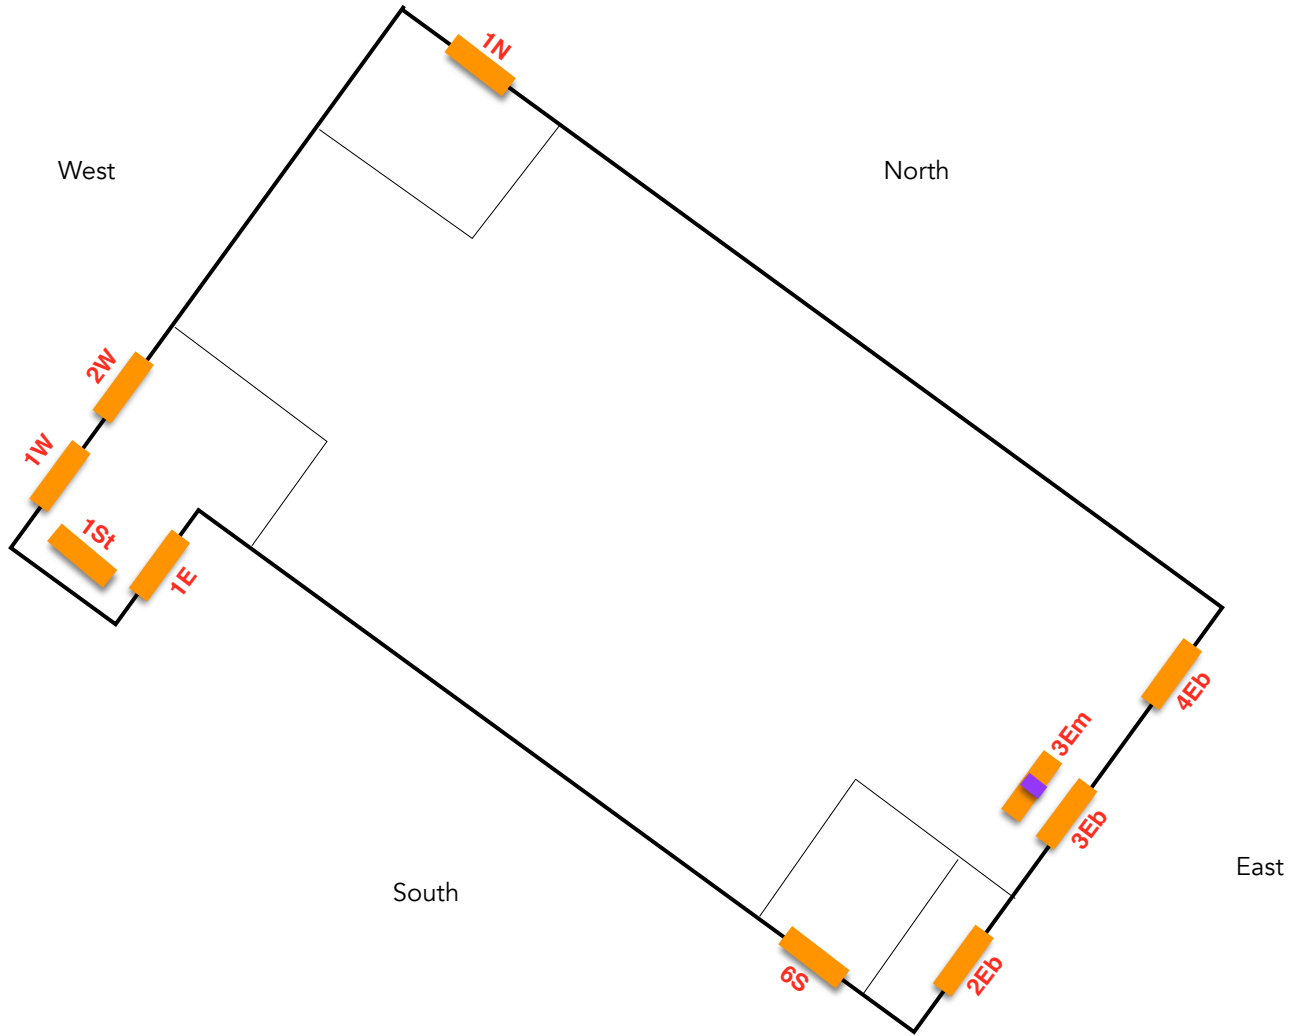
The below map indicates the windows that have been identified as needing repairs by a professional historic glass conservator - Stephanie Rogers. See following pages with detailed photos of the windows identified as needing attention.

1W Office area - faces west

Three sections - one is opener
Bottom boarder is bowed
Some re-bars are bending
